**Flood Control Project Maintenance
Levee Inspections**
LMA District Cover Sheet
Spring 2020 Levee Inspection Results

Sacramento River West Side Levee District

Spring 2020 Levee Inspection Results

Waterway			Bank	Unit Miles
Unit No. 01 Sacramento River			Right	49.64
	Spring (March - May)	Summer (June - August)	(September - November) Fall	Winter (December - February)
Unit Maintenance Rating (Fall Only)				
Date of Inspection	3/24/2020 - 3/24/2020			
DWR Inspector	Zach Jojola			
Accompanied By	Gary Marler RD0108

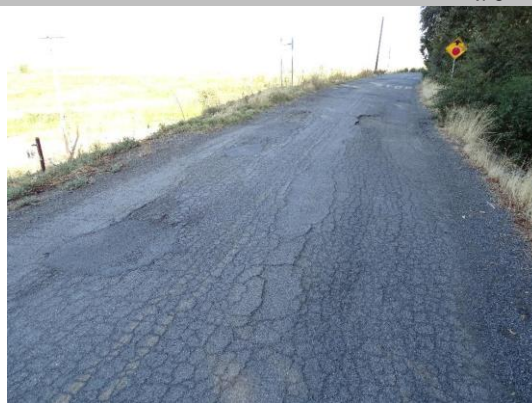
Photo 1 of 3 : UCIP_SP_2020_55791_82904.jpg

DS_ID:20224
 FS_ID:55791
 EP_NO: N/A
 Repair Type: Urgent
 Crossing Status: Found
 UCIP Comments: 9/30/2019 Record updated from Non-Urgent to Urgent. Erosion around headwall on WS progresses. Roger Cornwell who is a head of an irrigation district that operates the plant has been notified. Needs to run pumps to see if erosion is caused by leaking pipe(s). No permit has been identified authorizing pipe. (O.Yakimov - DWR UCIP)
 03/12/2013 Headwall on WS undermined about 3-4-feet. (W. Wylie - DWR UCIP)
 FIELD_STRUCT_DESC: 1 of 3: 36-inch steel drainage pipe through the levee, 30.0 feet below the crown. Flap gate on the waterside (WS) end. 24-inch pipe sleeved through the 36-inch pipe. Annular space between pipes grouted. Pumps in pump house with walkway on landside (LS) toe. [Additional Reference(s): DWR Levee Log, 2006, (HLM 0.15). USACE Sacramento O&M Manual 130, May 1960 (HLM 0.15), listed as three 36-inch pipes with gate on landside].

View of levee crown at the crossing

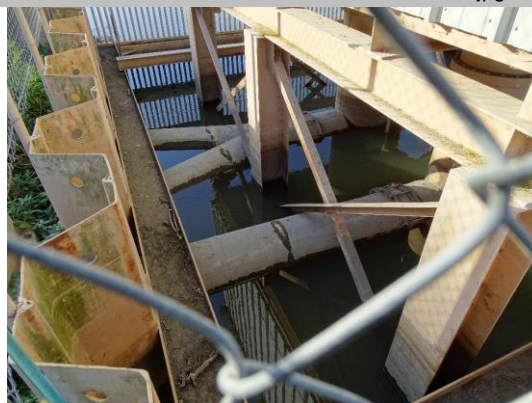
Photo 3 of 3 : UCIP_SP_2020_55791_82908.jpg

Pipe underneath pump house

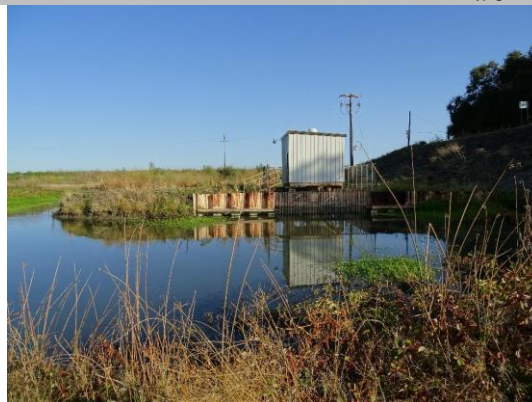
Photo 2 of 3 : UCIP_SP_2020_55792_82911.jpg

Comment Code						
Inspector Comment						
DS_ID:20356 FS_ID:55792 EP_NO: N/A Repair Type: Urgent Crossing Status: Found UCIP Comments: 9/30/2019 Record updated from Non-Urgent to Urgent. Erosion around headwall on WS progresses. Roger Cornwell who is a head of an irrigation district that operates the plant has been notified. Needs to run pumps to see if erosion is caused by leaking pipe(s). No permit has been identified authorizing pipe. (O.Yakimov - DWR UCIP) 03/12/2013 Headwall undermined 3-4-feet on WS toe. (W.Wylie - DWR UCIP) FIELD_STRUCT_DESC: 2 of 3: 36-inch steel drainage pipe through the levee, 30 feet below the crown. Flap gate on the waterside (WS) end. 24-inch pipe sleeved through the 36-inch pipe. Annular space between pipes grouted. Pumps inside pump house with a walkway on the landside (LS) toe. [Additional Reference(s): DWR Levee Log, 2006, (HLM 0.15). USACE Sacramento O&M Manual 130, May 1960 (HLM 0.15), listed as 36-inch pipes with gate on landside]. FS Date: 9/30/2019 8:01:37 AM

Pumping plant on LS

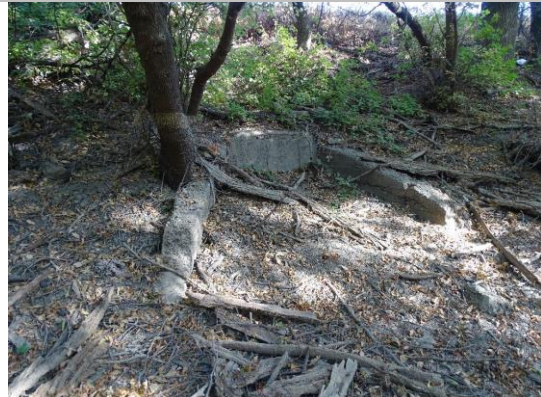
Photo 2 of 2 : UCIP_SP_2020_55794_82923.jpg

Comment Code					
Inspector Comment					
DS_ID:20327					
FS_ID:55794					
EP_NO: N/A					
Repair Type: Non-Urgent					
Crossing Status: Found					
UCIP Comments: 9/30/2019 Record updated from No Action Needed to Non-Urgent. No permit has been identified authorizing pipe. Crossing looks abandoned (O.Yakimov - DWR UCIP)					
FIELD_STRUCT_DESC: *ABANDONED* 42-inch drainage pipe of an unknown material through the levee, 28.5 feet below the crown.					
Abandoned in place by plugging with concrete. Headwall on waterside (WS) toe. [Additional Reference(s): USACE Sacramento O&M Manual 130, May 1960 (HLM 0.22), listed as 42-inch pipe].					
FS Date: 9/30/2019 9:45:45 AM

Concrete headwall and chute located at WS toe

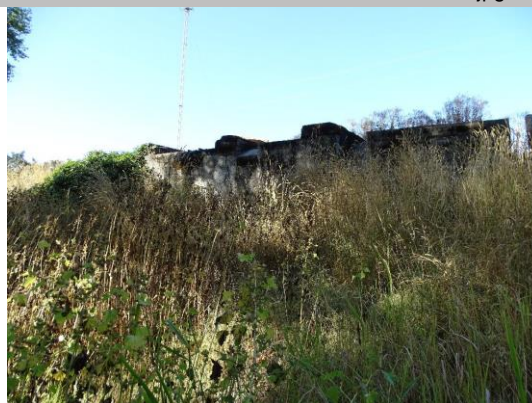
Photo 3 of 3 : UCIP_SP_2020_55798_82931.jpg

Concrete bulkhead on the WS slope

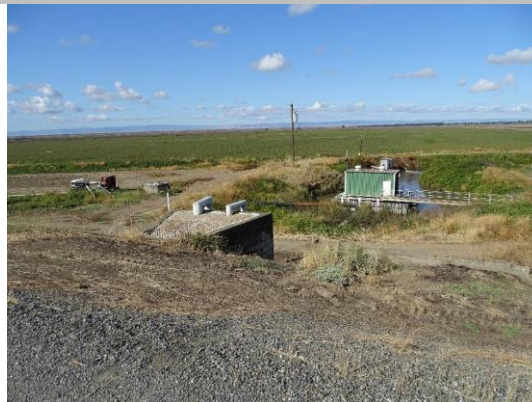
Photo 1 of 3 : UCIP_SP_2020_55802_82942.jpg

Comment Code						
Inspector Comment						
DS_ID:20331 FS_ID:55802 EP_NO: N/A Repair Type: Non-Urgent Crossing Status: Found UCIP Comments: 9/30/2019 Record updated from No Action Needed to Non-Urgent. No permit has been identified authorizing pipe. (O.Yakimov - DWR UCIP) FIELD_STRUCT_DESC: 5-foot by 5-foot reinforced concrete box drainage tunnel through the levee, 33 feet below the crown. Slide gate at outlet on the waterside (WS) toe. Tunnel runs from concrete U-shaped riser unit on the landside (LS) shoulder to the WS toe. Steel walkway to slide gate actuator on the WS berm. [Additional Reference(s): USACE Sacramento O&M Manual 130, May 1960 (HLM 3.59), listed as 5'x5' concrete tunnel with gate on landside]. FS Date: 9/30/2019 12:53:17 PM

View of LS looking from levee crown

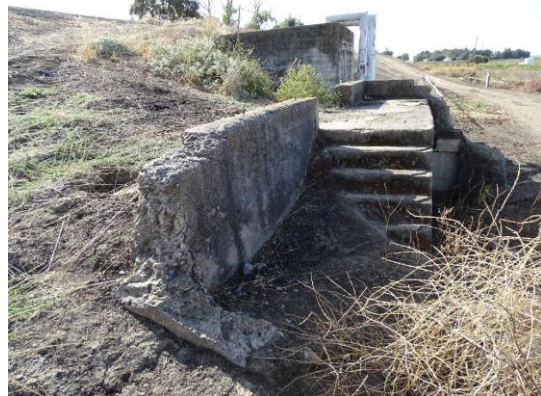
Photo 1 of 3 : UCIP_SP_2020_55806_82949.jpg

Disrupted structure at LS toe with stairs on the top of channel

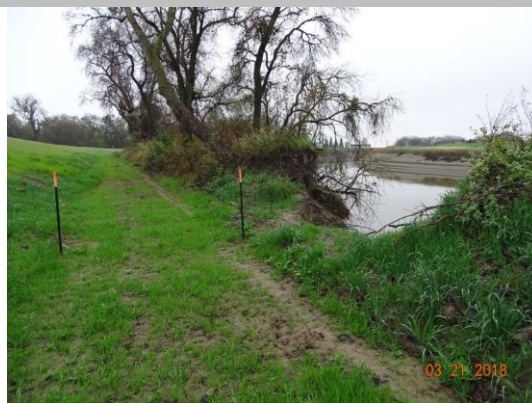
Photo 4 of 4 : SP_2020_NA0016_435_112_20200228_00041.jpg

LM Start	8.55	Rating **	A/W	Issue No.	112
LM End	8.55	Issue Type +	Ma	Location *	WS
Category	Earthen Levee			GPS Latitude/Longitude	
				Start	End
Item	Erosion / Bank Caving			38.857422 °	38.857422 °
				-121.780870 °	-121.780870 °
DWR ID	DWR_NA0016_01_s_2018_112				
Comment Code					
E1 : Note and monitor erosion site.					
Inspector Comment					
Location on waterside berm where oak tree fell and removed soil around the roots. Appears to be stable, but recommend monitoring.

Additional view of the berm. Spring 2018.

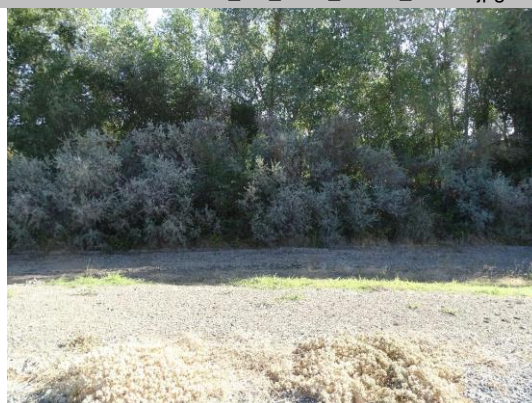
Photo 2 of 3 : UCIP_SP_2020_55904_83159.jpg

View of WS looking from levee crown. Gate valve wasn't found.

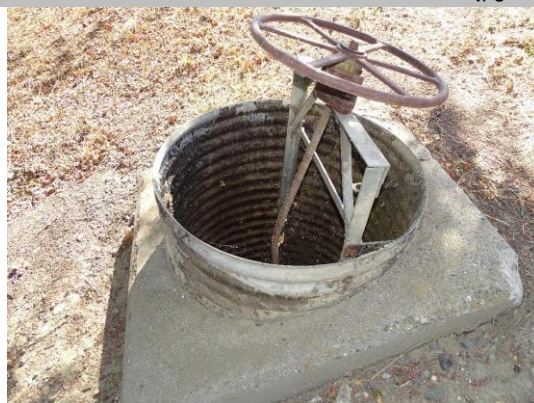
Photo 3 of 3 : UCIP_SP_2020_55911_83186.jpg

Bent stem of slide gate in CMP riser on WS slope

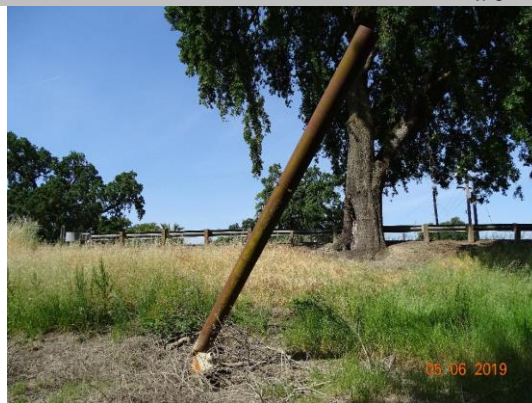
Photo 1 of 3 : UCIP_SP_2020_53980_79202.jpg

Bent metal standpipe at WS toe

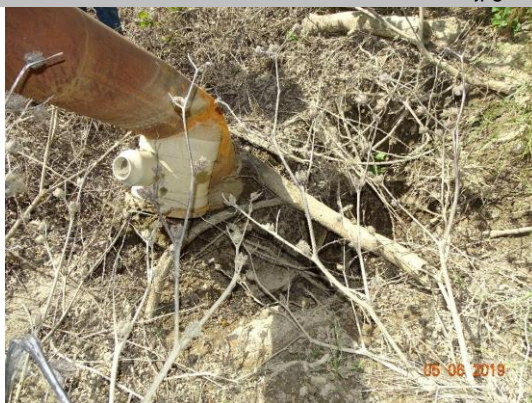
Photo 3 of 3 : UCIP_SP_2020_53980_79203.jpg

Damaged standpipe

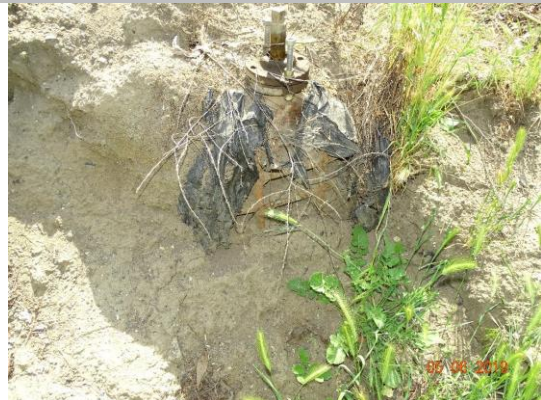
Photo 2 of 3 : UCIP_SP_2020_53982_79210.jpg

Gate valve silted at LS toe. Missing handwheel

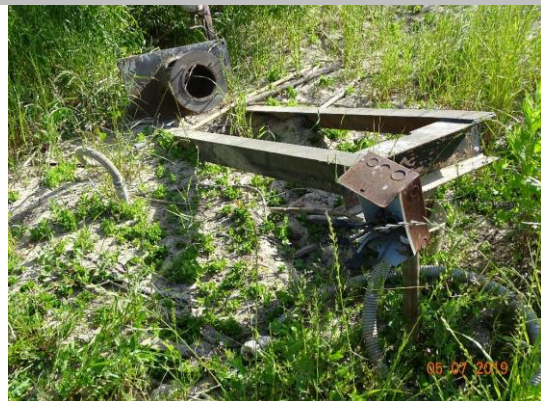
Photo 3 of 3 : UCIP_SP_2020_54149_79736.jpg

Slant pump on WS berm without motor

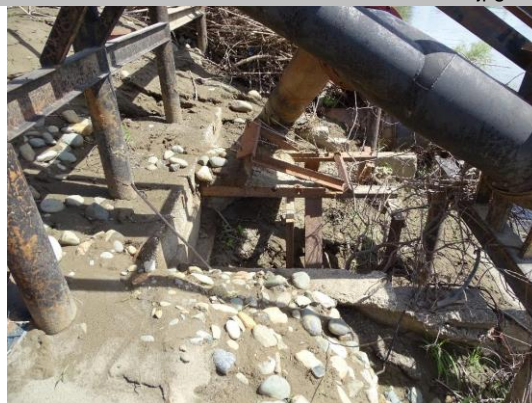
Photo 2 of 3 : UCIP_SP_2020_54197_79843.jpg

3'X6' concrete irrigation tunnel through the levee. Pipe is sealed at its entrance

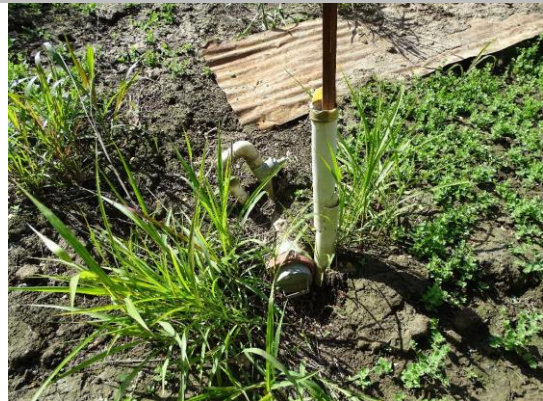
Photo 3 of 3 : UCIP_SP_2020_54225_79945.jpg

Capped pipe at WS toe

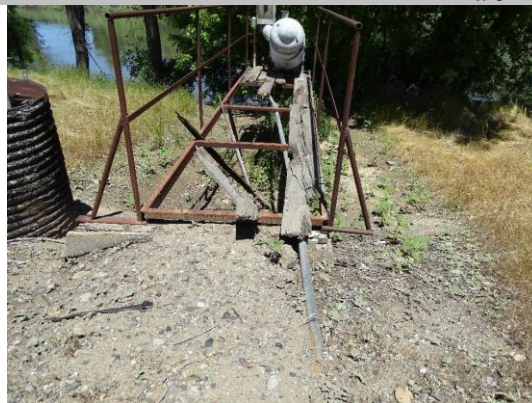
Photo 1 of 3 : UCIP_SP_2020_54244_79988.jpg

Disrupted walkway to the pump with conduit visible
